DAM INSPECTION CHECKLIST POSSUM POINT POWER STATION POND ABC

INSPECTION DATE: JAN. 19, 2016

INSPECTED BY: K. ACRE

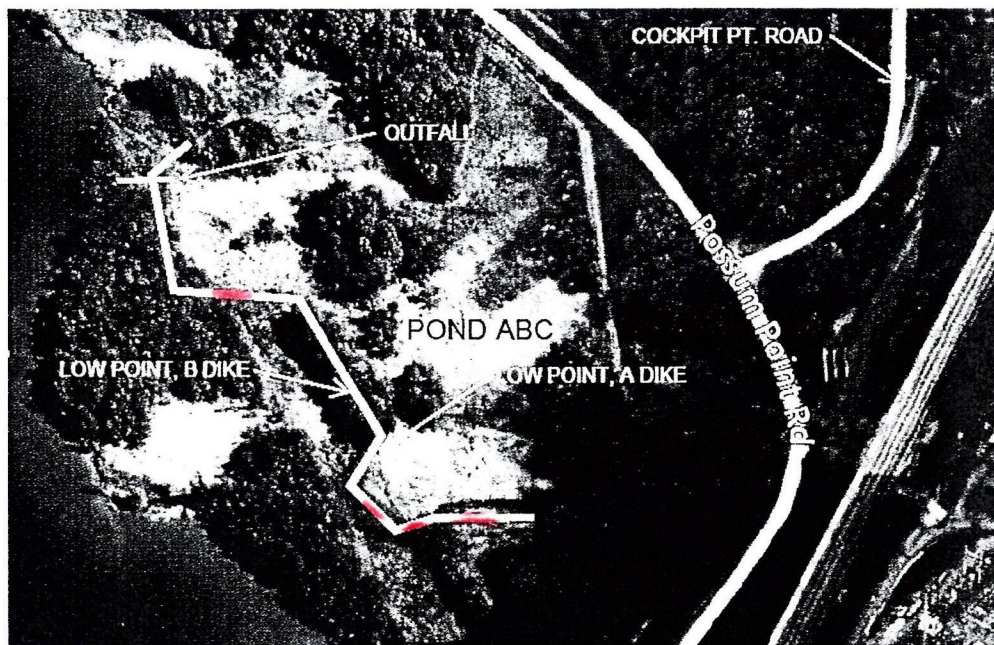
* See figure below.

Location/ Condition	(y/n)	Change (y/n)	Comments
Low Point, A dike*			
Flow	N	N	1040 SAND BAGS + RIPRAP IN PLACE AND NO STANDING WATER AGAINST SAND BAGS
Erosion	N	N	SEVERAL SAND BAGS ARE RIPPED
Low Point, B dike*			
Flow	N	N	1013 SAND BAGS ARE IN PLACE AND THERE IS NO STANDING WATER AGAINST SAND BAGS
Erosion	N	N	SEVERAL SAND BAGS ARE RIPPED
Outfall			
water surface El. (top of stoplogs to water)			10:30 NO STANDING WATER AGAINST WEIR AND WEIR IS DRY

Additional Comments (Note any changes observed along the embankment crest or downstream slope observed from the crest.): - LOW POINT, C DIKE -> SAND BAGS ARE IN PLACE, THERE IS NO STANDING WATER AGAINST SAND BAGS, AND SEVERAL SAND BAGS ARE RIPPED
 - SEVERAL AREAS WHERE STANDING WATER IS AT TOP OF EMBANKMENT, AS NOTED BELOW.
 - STANDING WATER AT TOP OF POND C EMBANKMENT, WITHIN POND. (TYPICAL OF ~~DIFF~~ ^{A+B} PONDS)
